Miscellaneous Paper CHL-98-6
August 1998

Toussaint River Unexploded Ordnance (UXO) Demonstration Dredging Project / by Timothy L. Welp, James E. Clausner, Raymond L. Pilon ; prepared for U.S. Army Corps of Engineers.

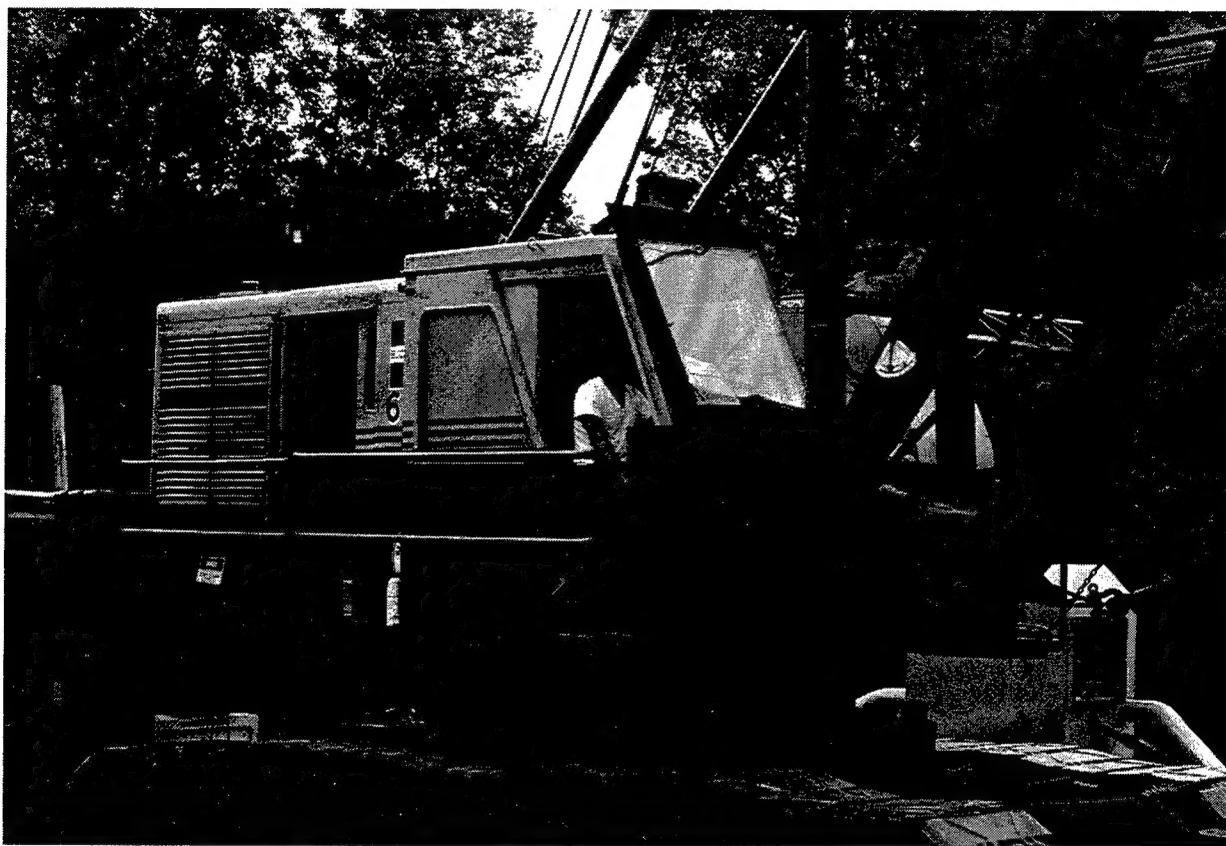
Engineering controls to counter health hazards due to potential UXO detonation consisted of enclosing the crane operator's booth with a 6.4-mm- (0.25-in.-) thick steel plate protection barrier with a viewport consisting of 64-mm- (2.5-in.-) thick polycarbonate laminate. This viewport provided the equivalent resistance of

6.4-mm- (0.25-in.-) thick mild steel plate (Figure 2). The 24-m (80-ft) crane was required because it allowed a minimum separation distance of 16 m (52 ft) between the operator and the clamshell bucket (also a protective barrier). The Huntsville Division designed the appropriate safeguards, including the protective barrier and the separation distance, using the computer program CONWEP to analyze effects of a potential detonation (i.e., equivalent weight of TNT, peak overpressure, fragmentation, etc.). This analysis was based on a 106-mm anti-tank round, the maximum-sized UXO perceived as a threat.

Figure 2. Crane operator's protective barrier

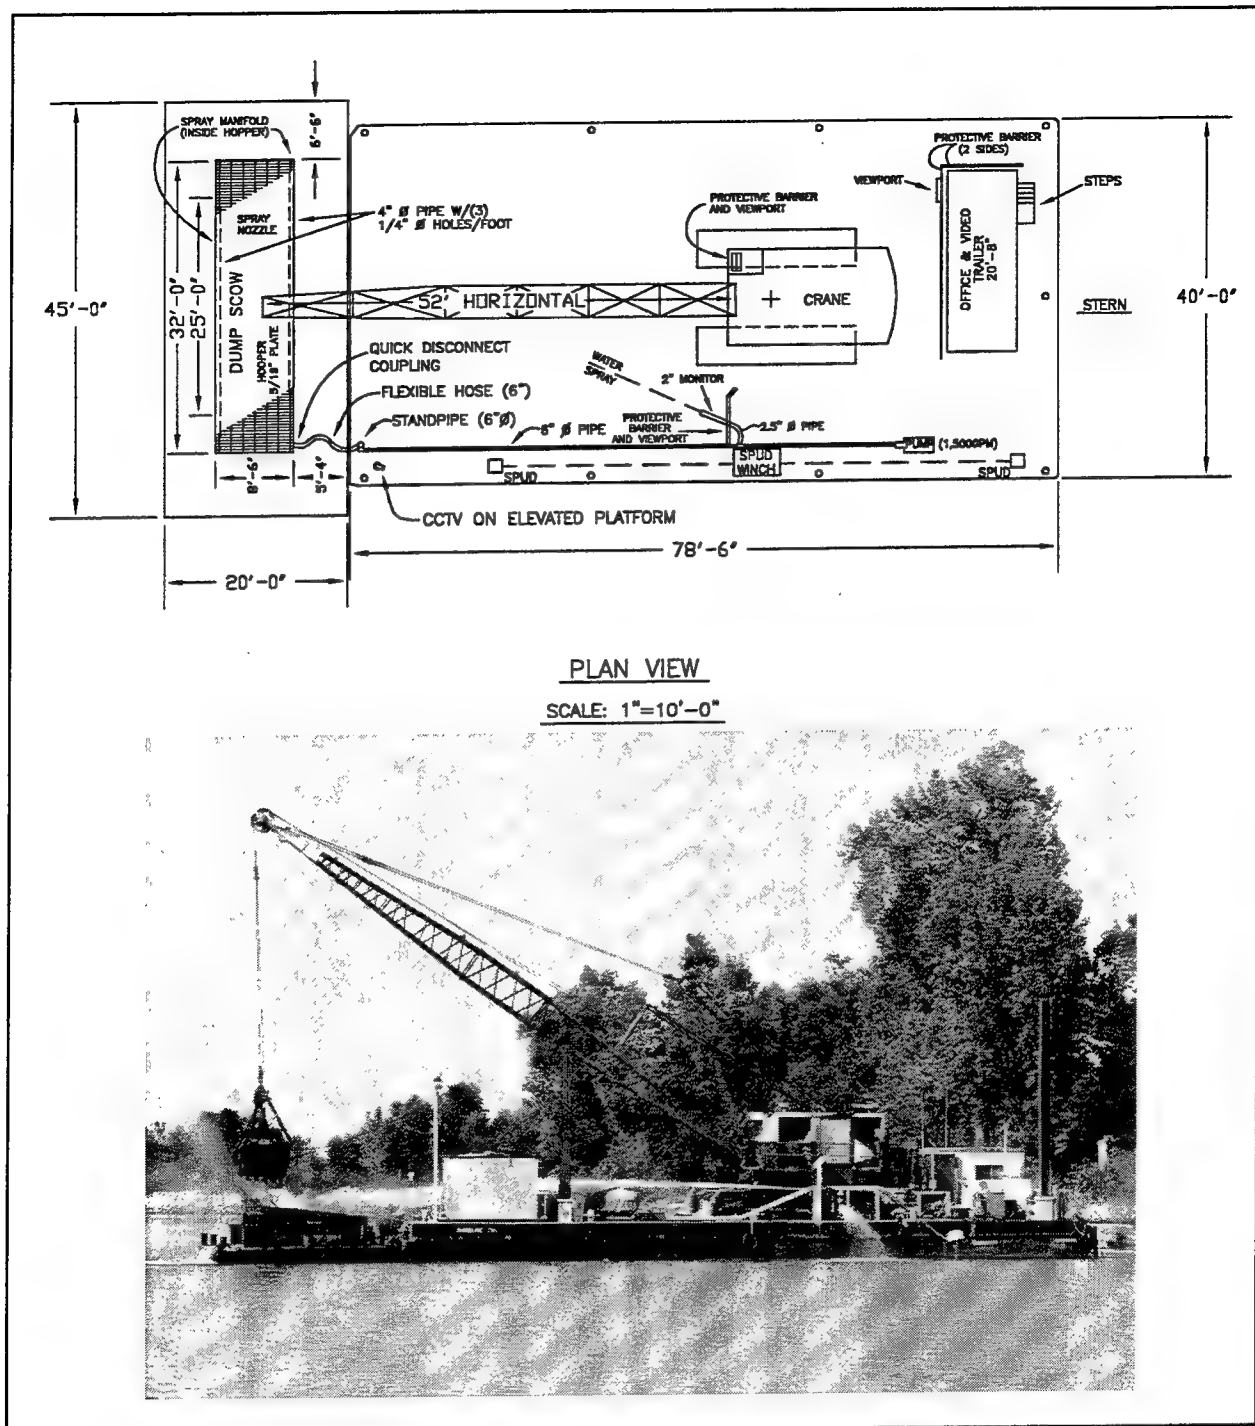
The clamshell excavated medium-sized sand (average d_{50} of 1.2 mm) from the navigation channel and dumped onto the scow secured "alongside" as shown in Figure 3. The project used two 65-m³ (85-yd³) capacity bottom-dump scows 14 m by 6 m by 2 m (45 ft by 20 ft by 6 ft) to transport dredged material to the disposal site. These scows were pushed with the work boat *Falcon*, an 11-m by 4-m by 0.8-m (36-ft by 12-ft by 2-1/2-ft) motor vessel equipped with pusher knees and propelled by a 350-hp diesel engine. The shallow drafts of the *Shoreline 785*, *Falcon*, and both scows allowed dredging to be conducted in water depths as shallow as 1.2 m (4 ft).

Figure 3. Deck layout (Courtesy of Shoreline Contractors, Inc.) and photograph of UXO dredging system

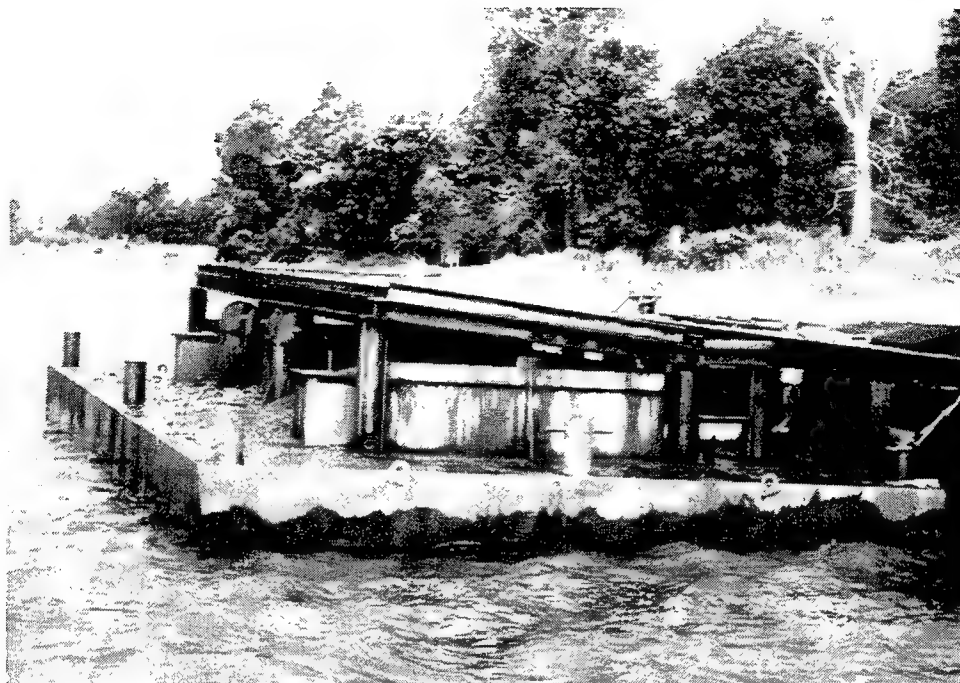
The separation screen was mounted over each scow on an I-beam support structure welded to the deck and inclined approximately 10 deg from the horizontal plane (Figure 4). In the event of a detonation, the screens were

Figure 4. Scow and separation screen

designed and constructed to allow damaged sections to be replaced or repaired. Each screen's 25-m² (272- ft²) total surface area was divided into two equal sections, 5 m by 2.6 m (16 ft by 8-1/2 ft) each that were removable to facilitate repair of detonation-induced damage and also to clean debris by lifting one side with the crane. The contract specifications required that the maximum screen opening dimensions be 19 mm (0.75 in.) in one direction and 127 mm (5 in.) in the other direction. These dimensions were based upon the design objective of retaining 20-mm projectiles. The screens used by the contractor initially consisted of coal-tar epoxy-coated bar grating with 19-mm by 114-mm (0.75-in. by 4.5-in.) openings that were 19 mm (0.75 in.) deep, but these dimensions were later modified as the project progressed (these changes are discussed later in the paper). Contract specifications required that the screen be constructed such that the maximum allowable opening dimensions were not to be exceeded even when it (the screen) was fully loaded with a design load of 4.6 m³ (6 yd³) of dredged material (approximately 8 tonnes (9 short tons)).

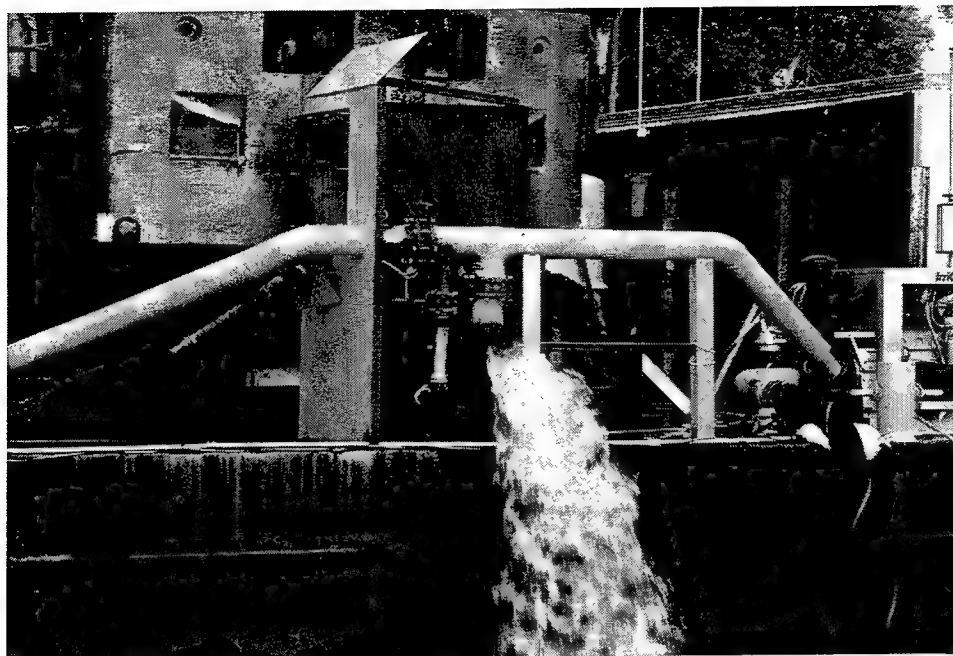
As the clamshell operator dumped dredged material onto the screen, a jet of water was manually directed into the dredged material from the water cannon station. This water jet facilitated screen throughput by fluidizing sediment and disintegrating the more cohesive clumps. The spraying system used a 100-mm (4-in.) (discharge) fire pump rated for 95 L/sec (1,500 gpm) at 24 bars (350 psi). This pump's discharge was coupled to a 152-mm (6-in.) expansion pipe system with a three-valve flow control system that regulated flow to the water cannon, excess overboard discharge, and the scow's internal spray system (Figure 5). The

Figure 5. Fluidization valve-control system

water cannon control valve regulated flow through a 64-mm (2.5-in.) flexible hose that was connected to a fire-fighting nozzle with a 64-mm- to 25-mm- (2.5-in.- to 1-in.-) diam reducer configuration (Figure 5). The water cannon operator was protected from potential UXO detonation by a protective barrier with the same construction materials and thicknesses as the crane operator's enclosure previously described. The nozzle was set in a gimballed mount located immediately below the viewing port and provided with a 6.4-mm- (0.25 in.-) thick steel rectangular protective barrier to cover the gimbal opening (Figure 6). This mount, comprised of two concentric swivels, provided the water cannon operator with two degrees of freedom to direct the water jet to any location on the entire screen surface.

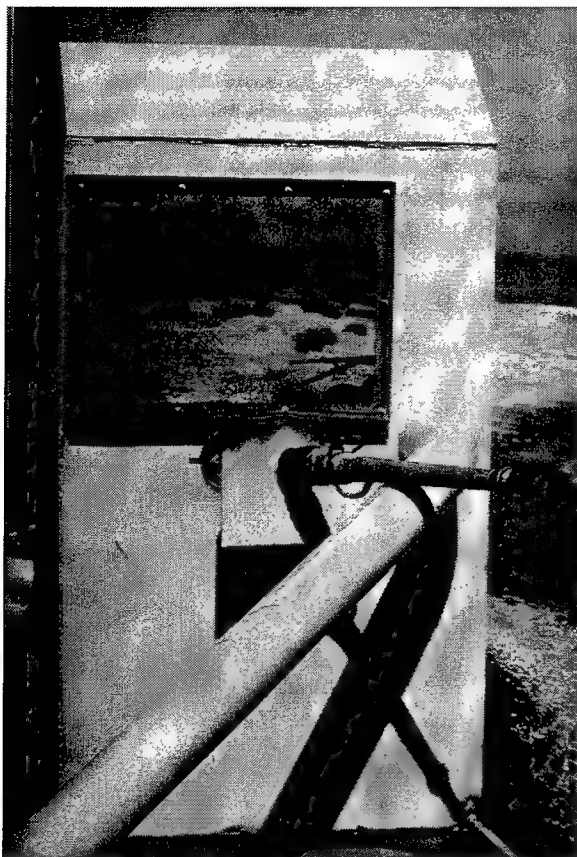
Figure 6. Water cannon operator's station

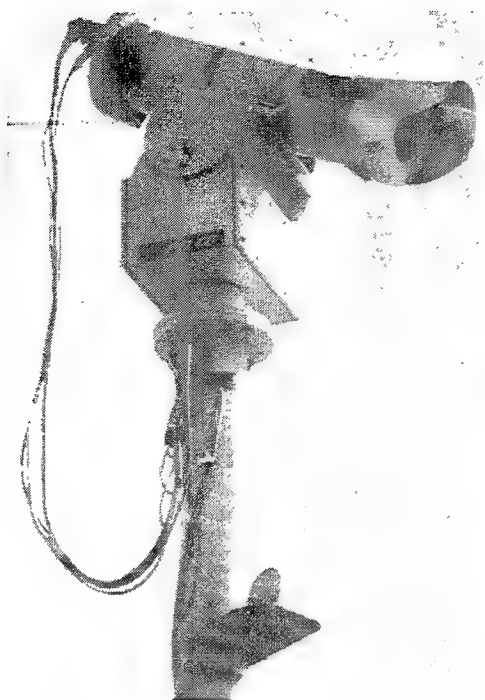
The screening process was visually monitored by EOD personnel in the observation trailer (OBST). Human Factors Applications Incorporated (HFA) of Holicong, Pennsylvania, provided EOD support during the demonstration in the form of equipment and personnel to locate, identify, recover, transport, and dispose of ordnance encountered. The OBST was equipped with a steel protective barrier and polycarbonate viewport on the side facing the screen (Figure 3). During the actual dredging, all personnel except the water cannon and crane operators were stationed inside the OBST. A closed-circuit television (CCTV) high-resolution camera lens was mounted on a 4.6-m (15-ft) mast near the screening area. The camera's 10X f1.8 motorized zoom lens with auto iris was housed in

an explosion-proof and waterproof enclosure equipped with remote-controlled pan and tilt capabilities (Figure 7).

Figure 7. 10X zoom lens with remote-controlled pan and tilt

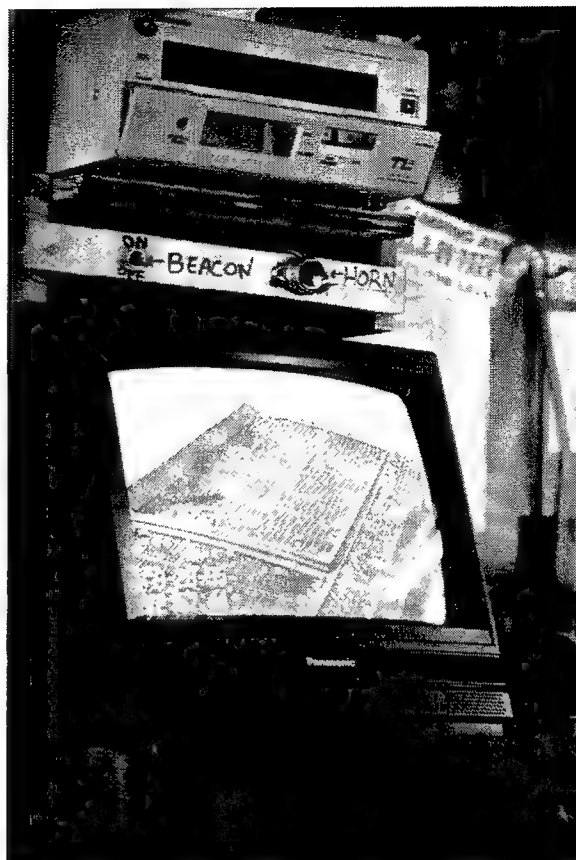
An operator in the OBST controlled the camera's zoom, pan, and tilt functions. A color video monitor and time-lapse recorder were connected to the camera via a fiber-optic link to provide color-corrected professional-quality images (Figure 8). The CCTV field of view provided coverage of the entire screen surface. As a surveillance system backup, one EOD person monitored the screening process by looking out the view port with binoculars.

Figure 8. CCTV control station inside the OBST (lens zoomed out)

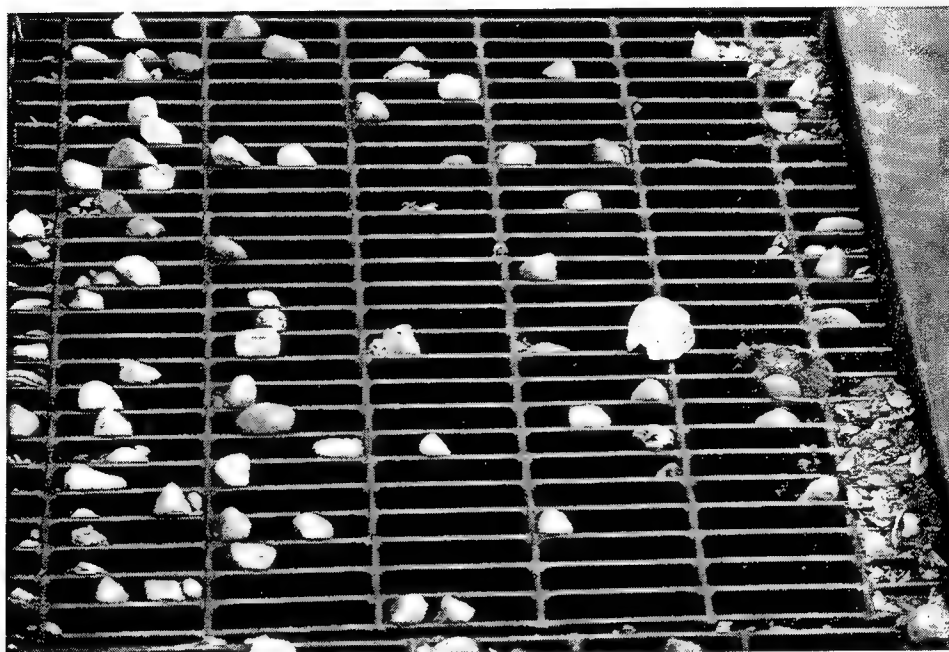
Soon after dredging commenced, it became obvious that, even with the combination of water cannon jet and scow internal spray acting on the sediment, the screen's 19-mm by 114-mm (0.75-in. by 4.5-in.) rectangular openings were becoming excessively clogged (blinded off) by clamshells and rounded coarse gravel (Figure 9). Cleaning the debris that were wedged between the grates proved to be a very time-consuming, labor-intensive job. As the clamshell excavated deeper into the sediment, unexpected amounts of clay (brown-gray with medium high plasticity) and peat were encountered. This clay further decreased production due to the water spraying systems' inability to disintegrate the more cohesive clumps.

Figure 9. Blinded-off bar grate separation screens

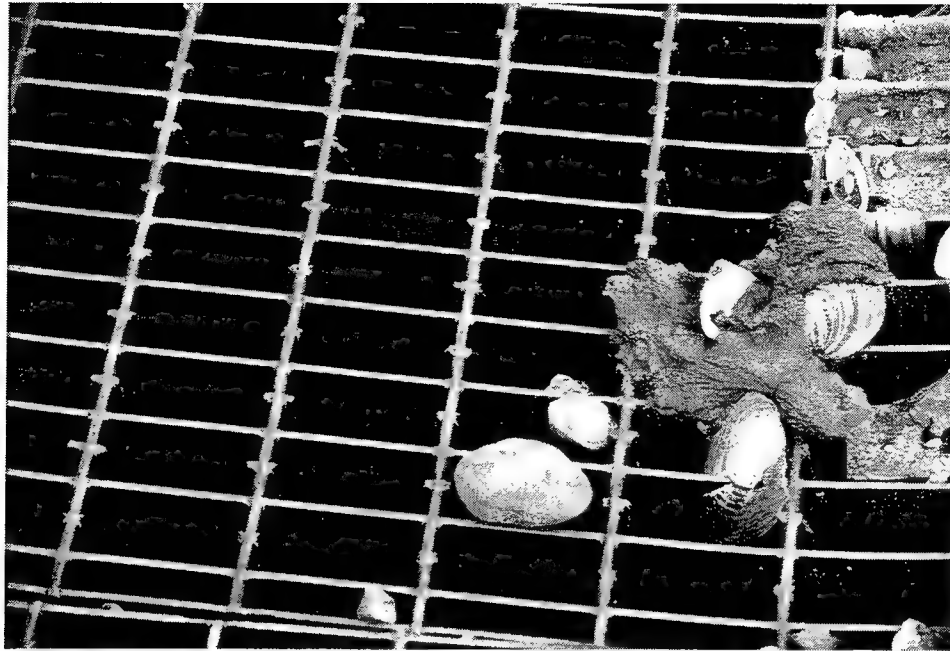
These increased amounts and types of debris remaining on the screen surface after the scow was full, would, in turn, increase the time required by EOD personnel to safely inspect and clear. With approval from the Huntsville Division, it was decided to expand the screen opening area by cutting out every other lateral grate bar. Removal of these laterals increased the rectangular dimensions to 38 mm by 114 mm (1.5 in. by 4.5 in.) (Figure 10). This modification dramatically increased screen throughput by allowing more clamshells and coarse gravel to pass through (less blinding), but, when encountered, the more cohesive clumps of clay and peat still remained troublesome.

Figure 10. Modified bar grate screens

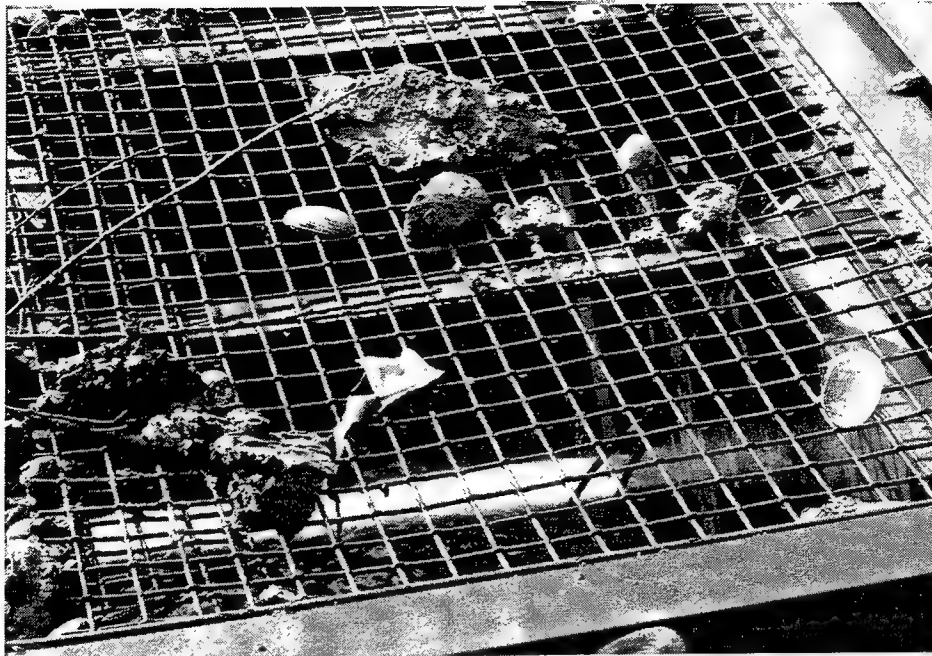
"Space cloth" made from 6.4-mm- (0.25-in.-) diam round stock with 50-mm by 50-mm (2-in. by 2-in.) square openings was used to replace the more damaged grate sections (Figure 11), but the use of this type of screen required welding

Figure 11. Space cloth separation screen

additional I-beam cross members into the screen frame for support. After this modification, no significant difference in throughput rates was noticed for the space cloth as compared to the modified bar grate.

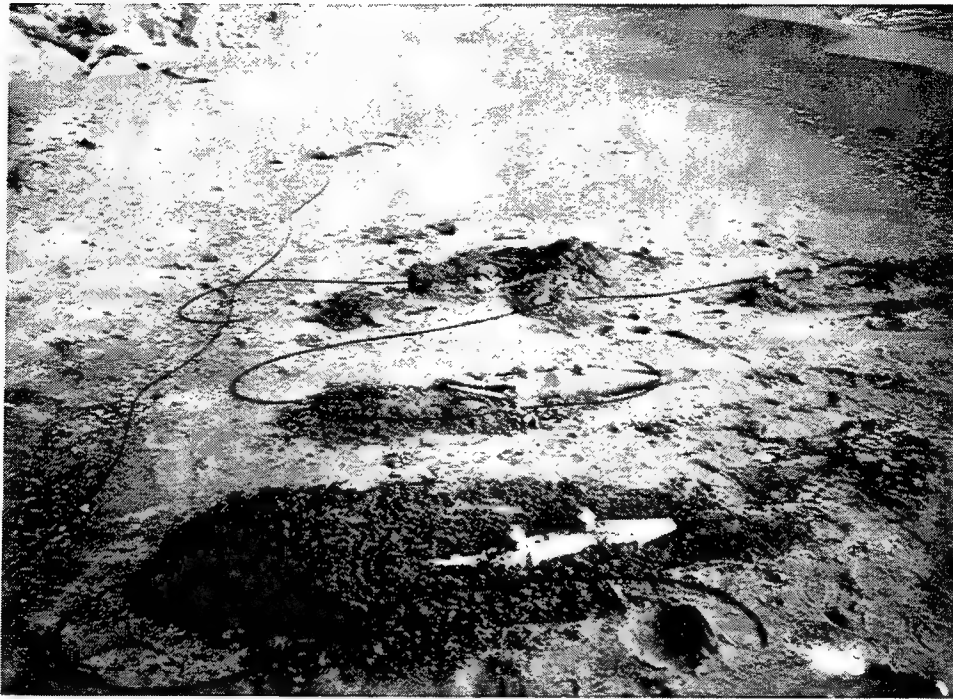
If the target was ordnance, as it was after the 8th day of dredging (a smoke grenade and 106-mm projectile), a 5-m (16-ft) diesel-powered (reduced fire hazard) boat piloted by another EOD specialist would be brought up alongside and the ordnance would be sand-bagged, and transported to shore. At the disposal site, the ordnance was laid in a shallow pit and shaped charges were fastened to its casing (Figure 12). Detonation cord was used to initiate the shaped charges and the focused energy of the explosion breached the ordnance's casing. Only after a casing was breached could an item be conclusively classified as UXO or inert ordnance.

Figure 12. Ordnance prepared for disposal detonation

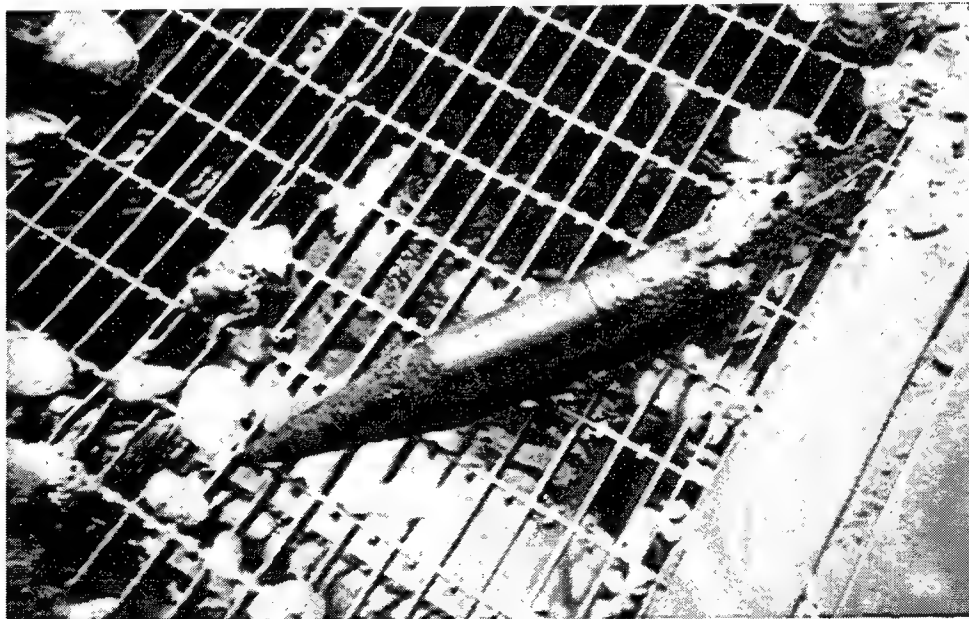
During the 79-work-day duration of the demonstration project, 14,757 m³ (19,300 yd³) of material was removed from the authorized channel limits (as determined by hydrographic survey) during 72 actual days of dredging. The remaining 7 days were spent conducting various tasks such as altering screens, repairing the dredge plant, etc. A total of 37 pieces of ordnance were recovered from the separation screens and properly disposed of (resulting in 568 lb of scrap metal). From this total, 31 pieces were classified as inert ordnance, and the remaining 6 as UXO (HFA Inc. 1996). In Figure 13, a 106-mm projectile can be seen in the condition that it was recovered from the screen. Table 1 classifies the total amount of ordnance recovered during the demonstration and Figure 14 shows several different types of ordnance recovered during the demonstration (note condition of 60-mm mortar in lower right-hand corner after being breached by shaped charge).

Figure 13. 106-mm projectile on the separation screen

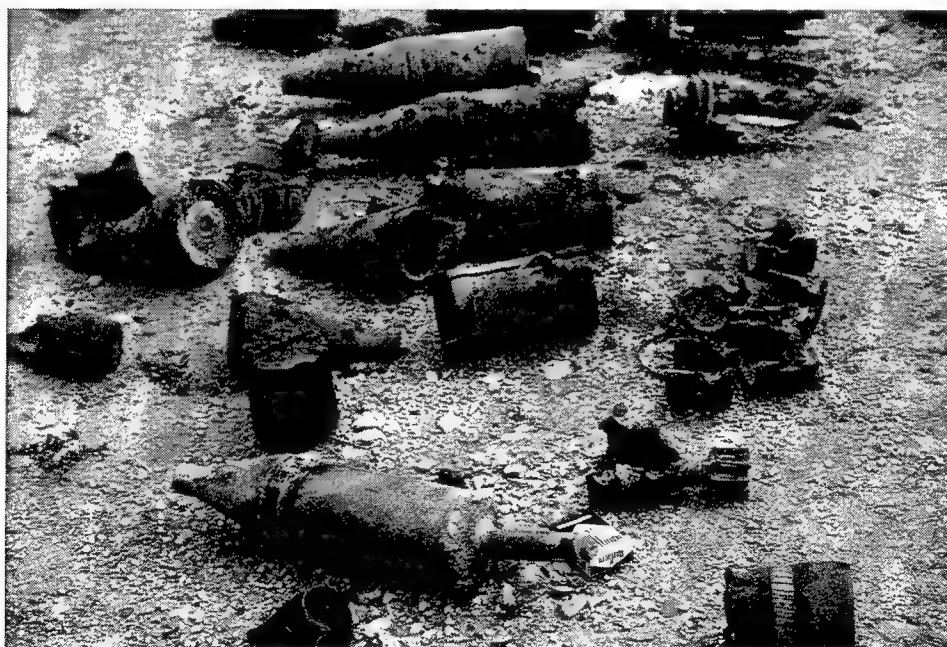
Table 1 Total Ordnance Recovered	
Ordnance Type	Quantity
UXO	
M28 3.5-in. rocket	4
M49A2 60-mm mortar	2
Inert Ordnance	
M344 106-mm projectile	22
M52 fuze	1
M489 105-mm projectile	3
M333 90-mm projectile	1

Figure 14. Several examples of recovered ordnance
